# MacBook Pro 13" Unibody Late 2011 Hard Drive Cable Replacement

Replace the hard drive cable in your Late 2011 MacBook Pro 13" Unibody.

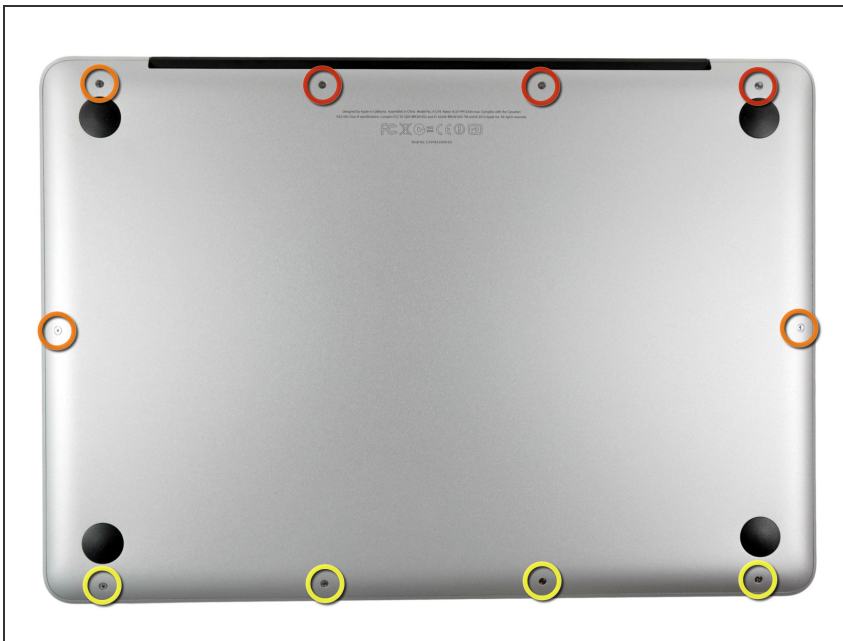
## Step 1 — Lower Case

- Remove the following ten screws:
  - Three 14.4 mm Phillips #00 screws
  - Three 3.5 mm Phillips #00 screws
  - Four 3.5 mm shouldered Phillips #00 screws

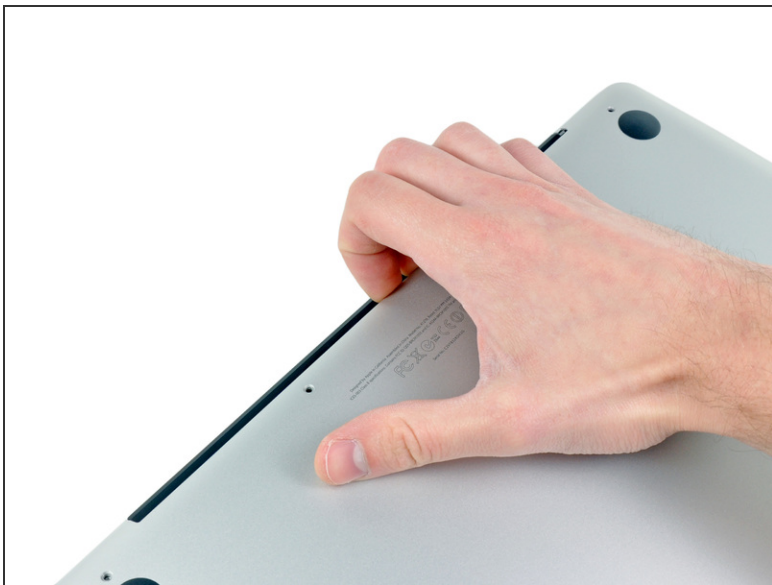
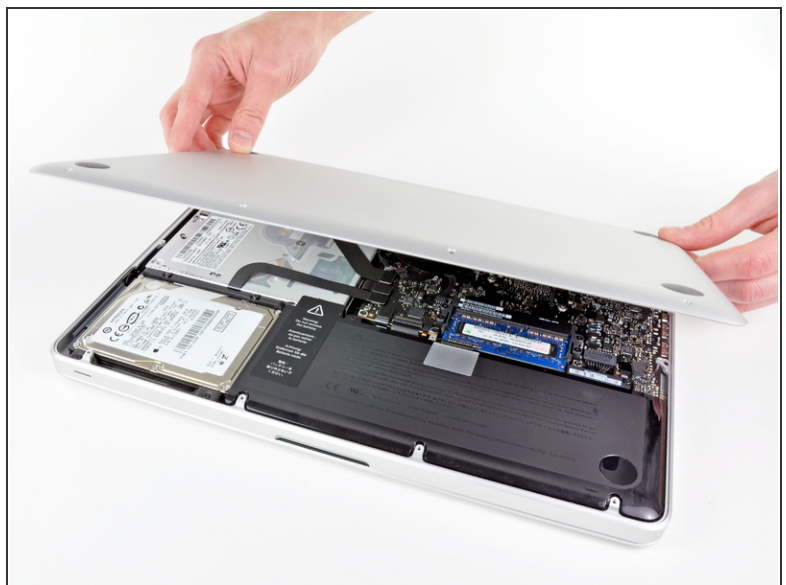
## Step 2

- Use your fingers to pry the lower case away from the body of the MacBook near the vent.
- Remove the lower case.

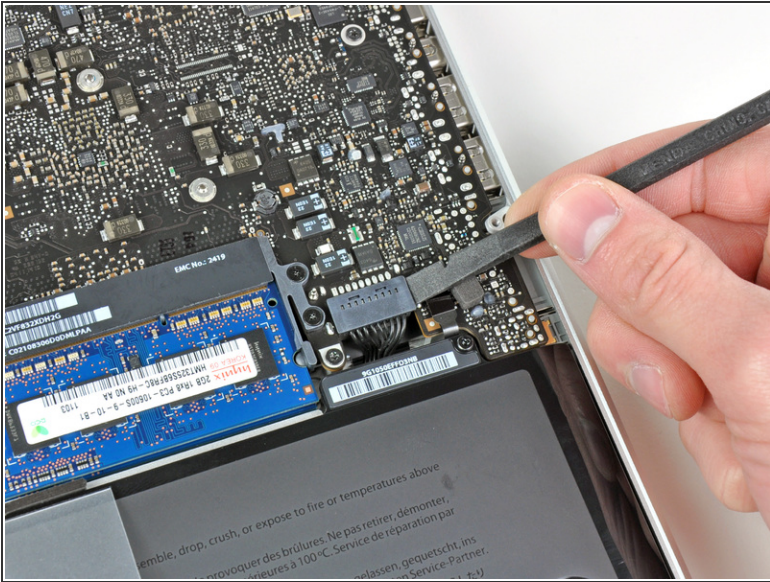
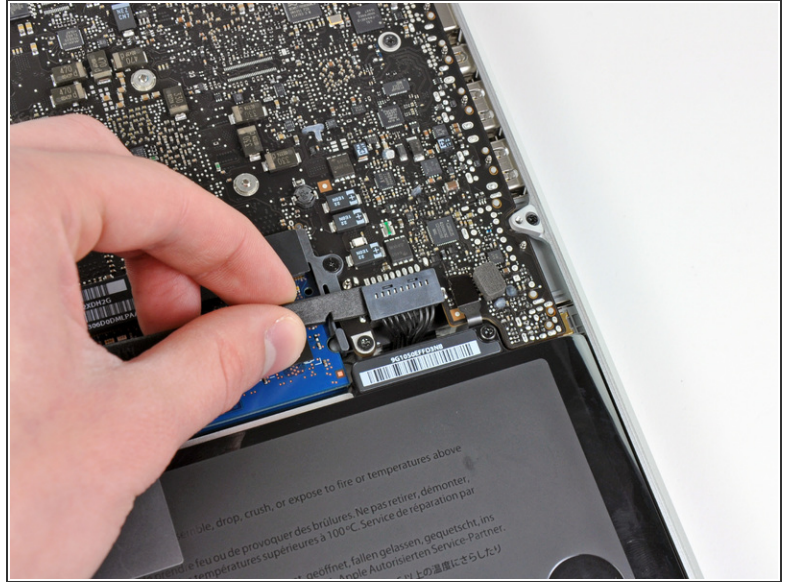
## Step 3 — Battery Connection

- Use the edge of a spudger to pry the battery connector upwards from its socket on the logic board.
- ⓘ It is useful to pry upward on both short sides of the connector to "walk" it out of its socket. Be careful with the corners of the connectors, they can be easily broken off.

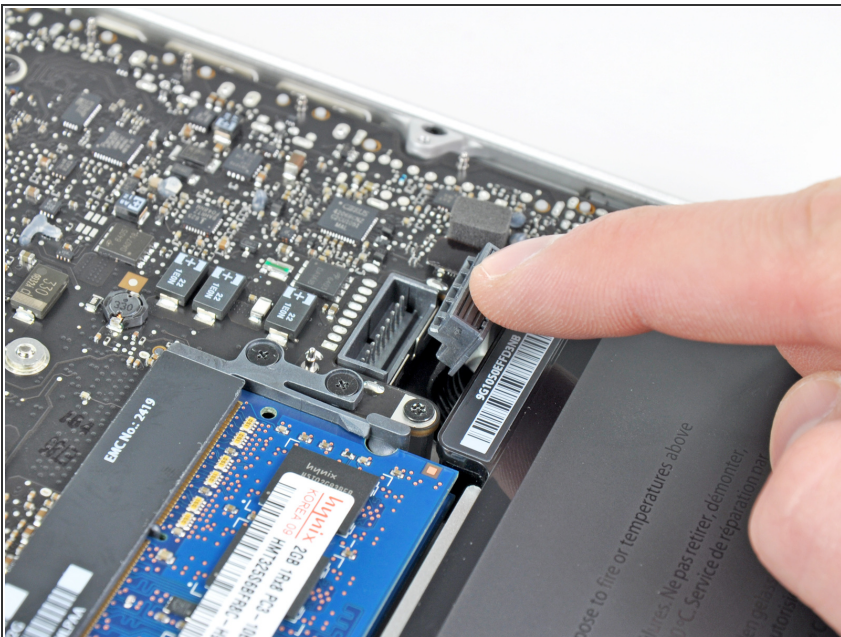
## Step 4

- Bend the battery cable slightly away from its socket on the logic board so it does not accidentally connect itself while you work.

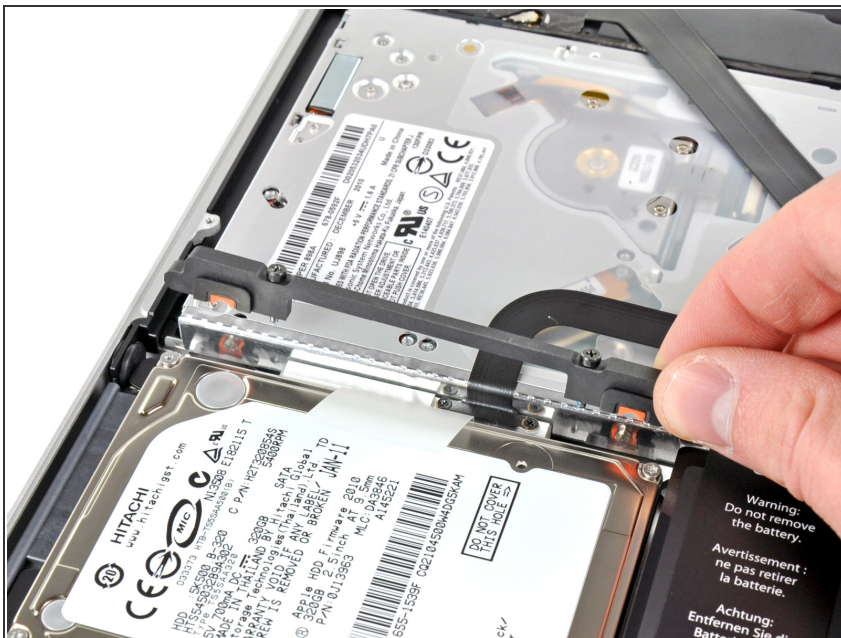
## Step 6

- Remove the hard drive bracket.
- ⓘ The hard drive bracket may be firmly seated against the upper case.

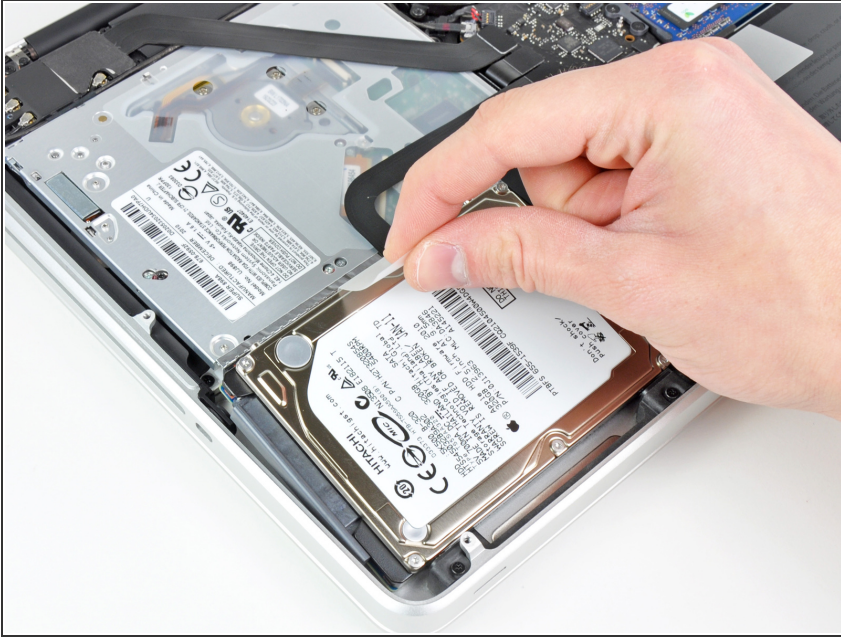
## Step 7

- Use the attached pull tab to lift the hard drive out of the upper case.

⚠ Don't try to completely remove the hard drive just yet. It is still attached to the hard drive cable.

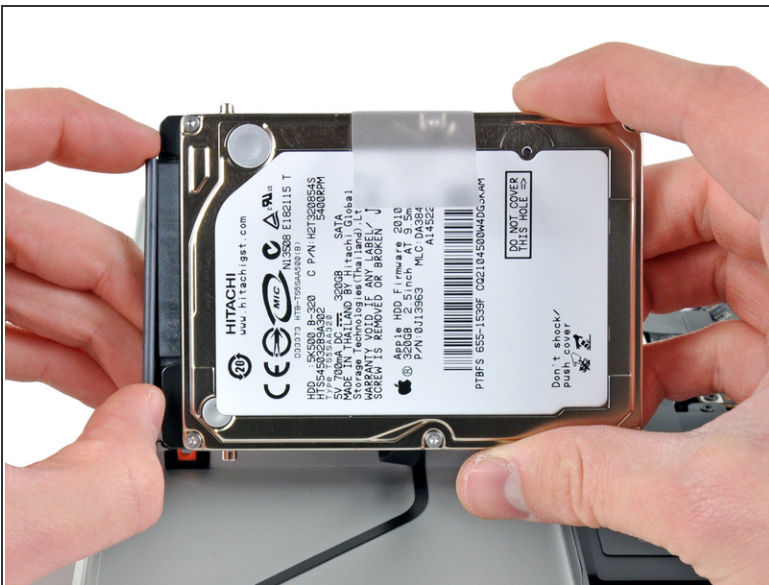
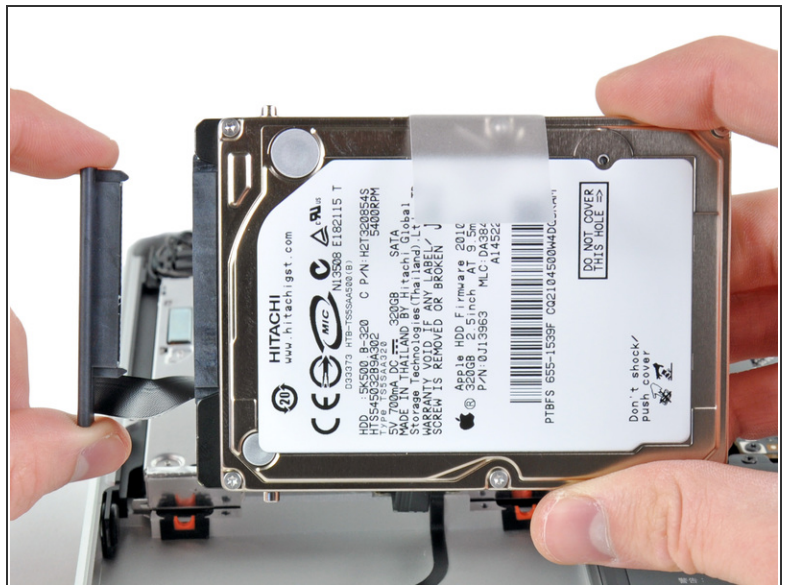
## Step 8

- Pull the hard drive cable away from the body of the hard drive.
- Remove the hard drive.

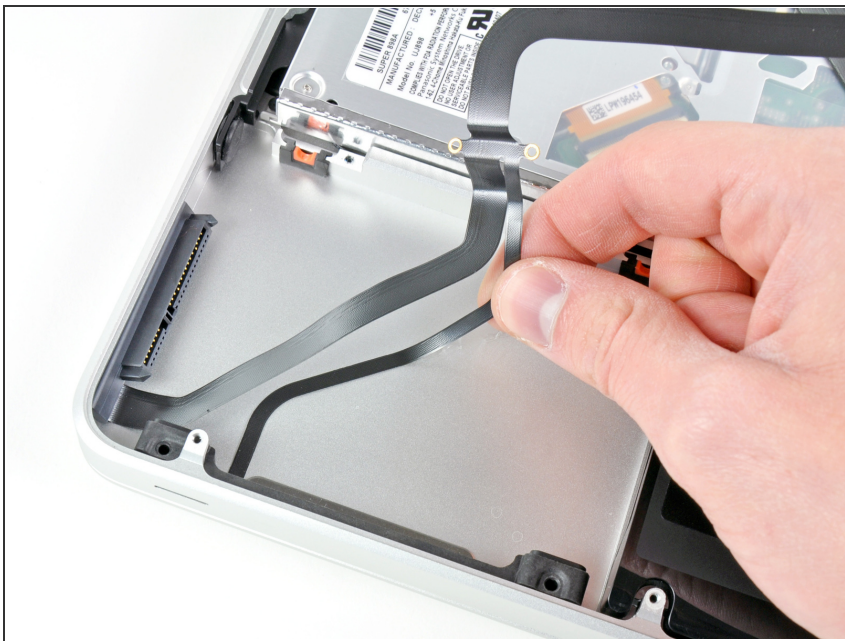
## Step 11

- Carefully peel up the thin IR sensor/sleep LED ribbon cable from the adhesive securing it to the upper case.

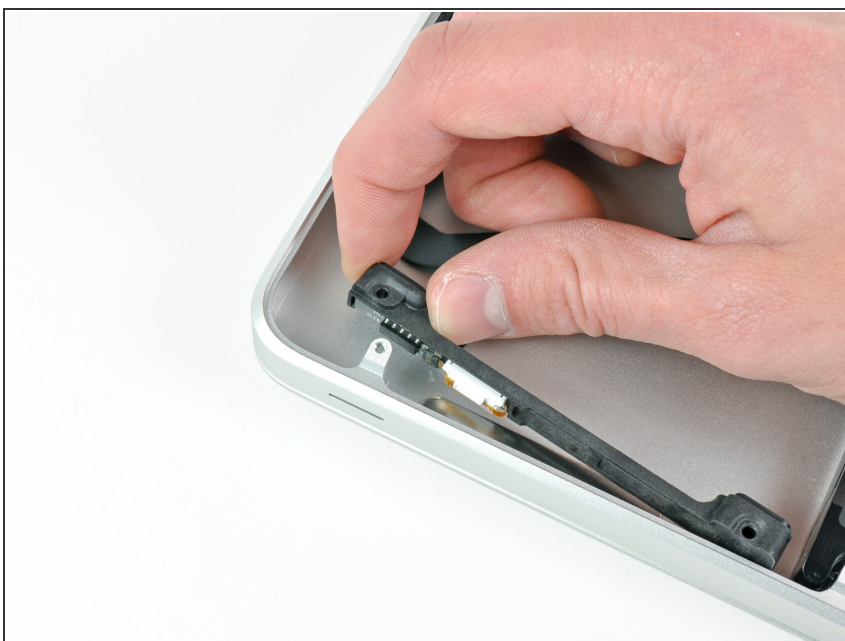
## Step 12

- Pull the front hard drive bracket containing the IR sensor/sleep LED away from the front edge of the upper case.
